May 2009

Rio Piedras Conservation Management Plan

RIO PIEDRAS CONSERVATION MANAGEMENT PLAN

Prepared For: The Conservation Trust of Puerto Rico

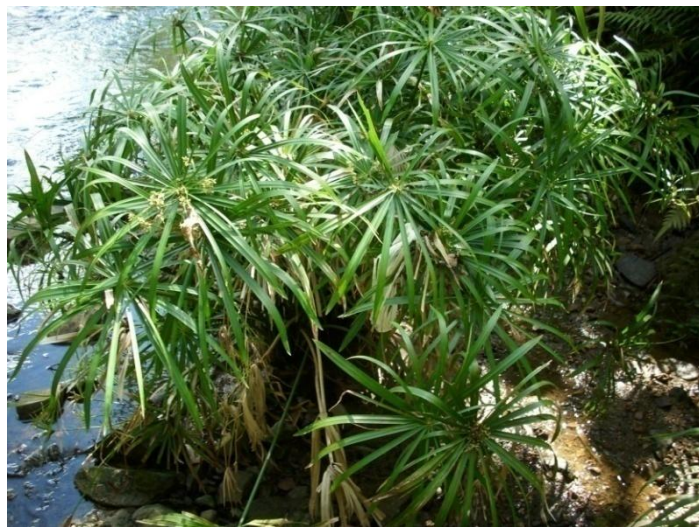
Figure 10: Invasive Papiro of Zone 2

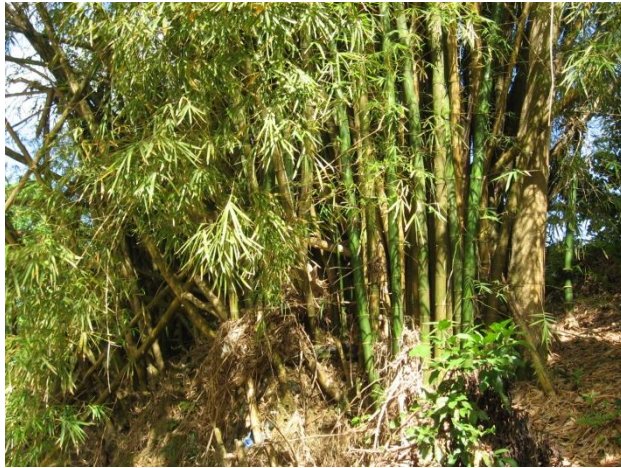
Figure 26: Bamboo Cluster and Erosion in Zone 9

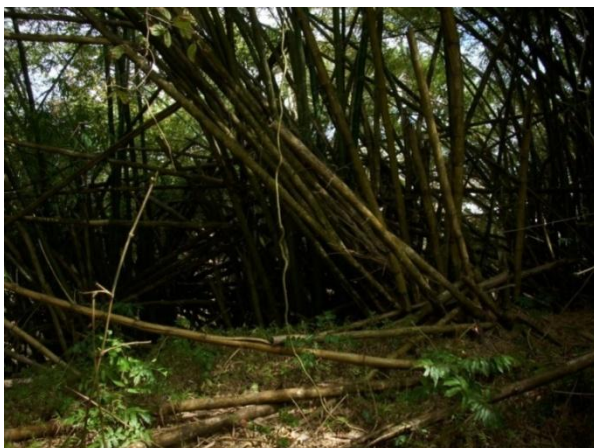
Figure 29: Bamboo Debris of Zone 11
